Metal Forming Success Story

Cowles Stamping Relies on Phygen FortiPhySM UltraEnduranceSM Coating to Eliminate Premature Punch Failure and Increase Production Runs

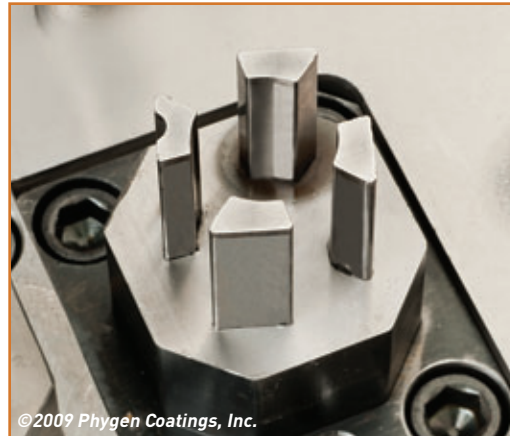
Phygen-coated punches do not catch in the material. "The lubricity is spectacular," says Couture. "We don't have any problems with material catching the punches and breaking them."

"The lubricity from the new coating is spectacular. We no longer have problems with the material catching the punches and breaking them," says Couture. Phygen FortiPhySM coating uses the physical vapor deposition (PVD) coating technology, based on principles of plasma acceleration, for higher plasma density and an intense, low-energy ion bombardment during coating deposition. Unprecedented toughness, lubricity and outstanding uniformity are a few benefits of coatings formed by this process, state Phygen officials.

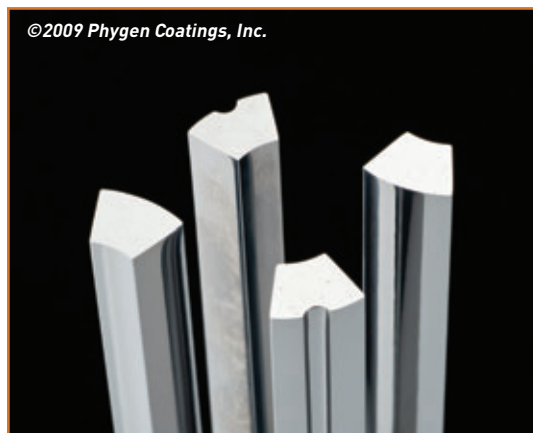
Parts stamped from punches coated in Phygen's FortiPhySM UltraEnduranceSM coating.
